MITIGATING ELEVATED LEVELS OF LEAD AND COPPER IN ADAK'S DRINKING WATER SYSTEM BY REPLACING RESIDENTIAL FAUCETS

April 19, 2002

**Engineering Field Activity, Northwest
Naval Facilities Engineering Command
19917 7TH Avenue NE
Poulsbo, WA 98370-7570**

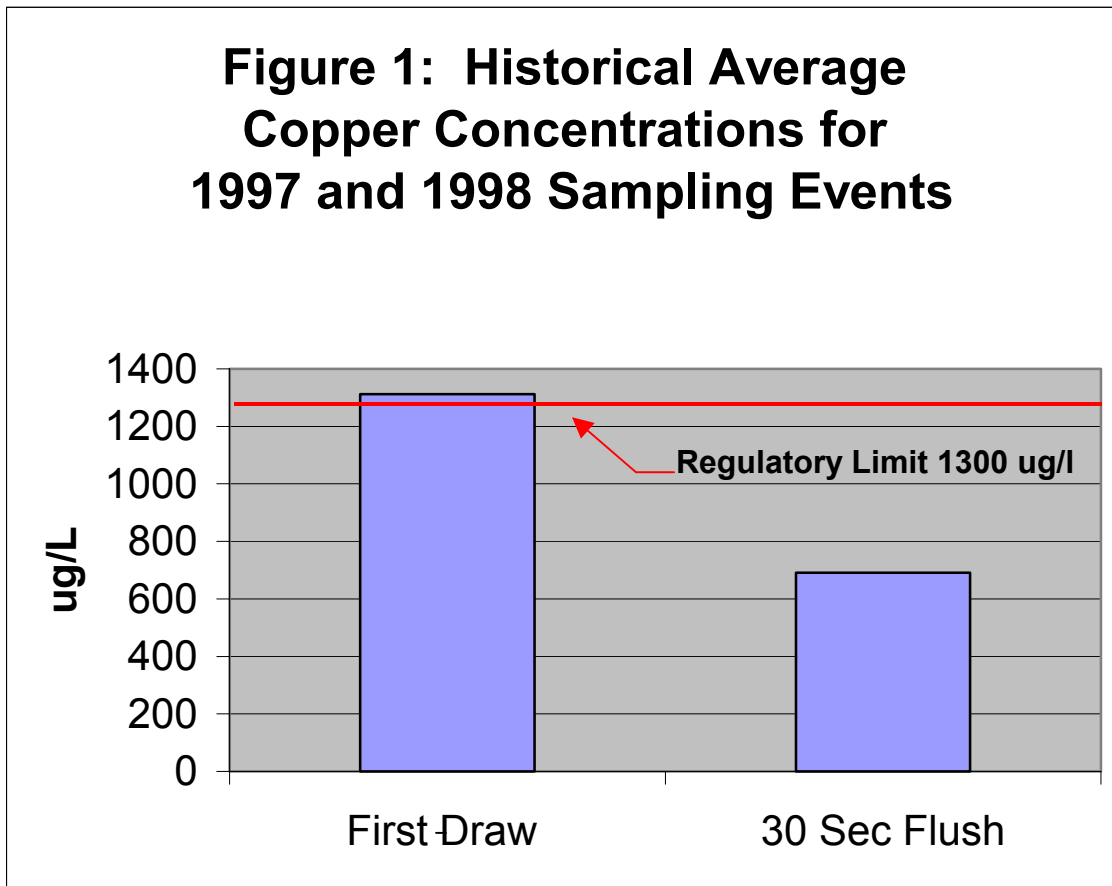
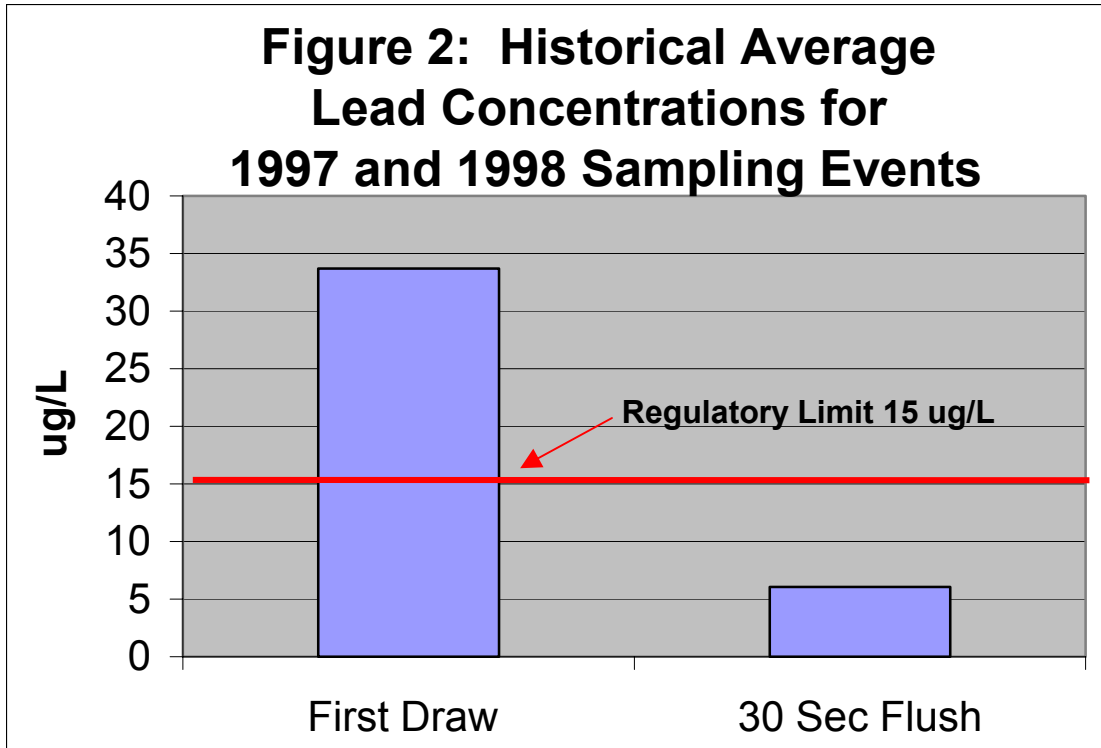
The two figures below show the average lead and copper concentrations that were recorded during the two separate sampling events conducted in 1997 and 1998.

As the two figures illustrate, the water leaches metal from the plumbing system if it is left standing in the interior piping for a period of time. Based only on the historical data collected prior to this faucet study, it was unknown if the source of the metal was the faucets, the internal plumbing system, or a combination of the two.

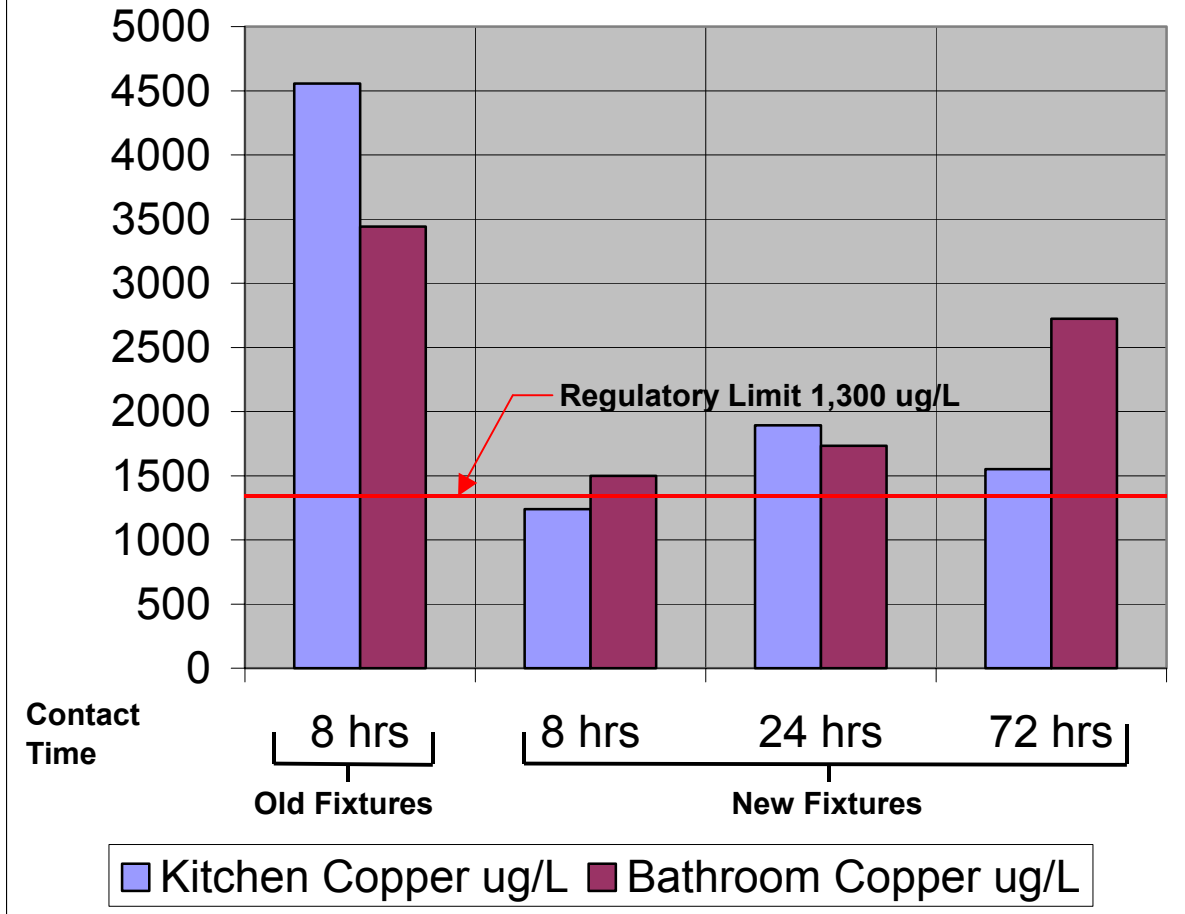
Figure 3: Average Copper Concentrations

The analytical data clearly shows that replacing the existing fixtures had a positive effect upon the water quality within the residential housing units. Both lead and copper concentrations were reduced subsequent to faucet replacement. The overall reduction of lead and copper levels was found to be 86% and 67%, respectively. Appendix B includes a graphical representation of the sampling results from each housing unit.

Based upon the supporting data, it is recommended that the fixtures from each Sandy Cove housing unit be replaced. This will remove from service a primary source of lead and copper, thus significantly reducing the concentration of the metals in the drinking water. This passive alternative would be preferable to installing a source treatment system for the following reasons:

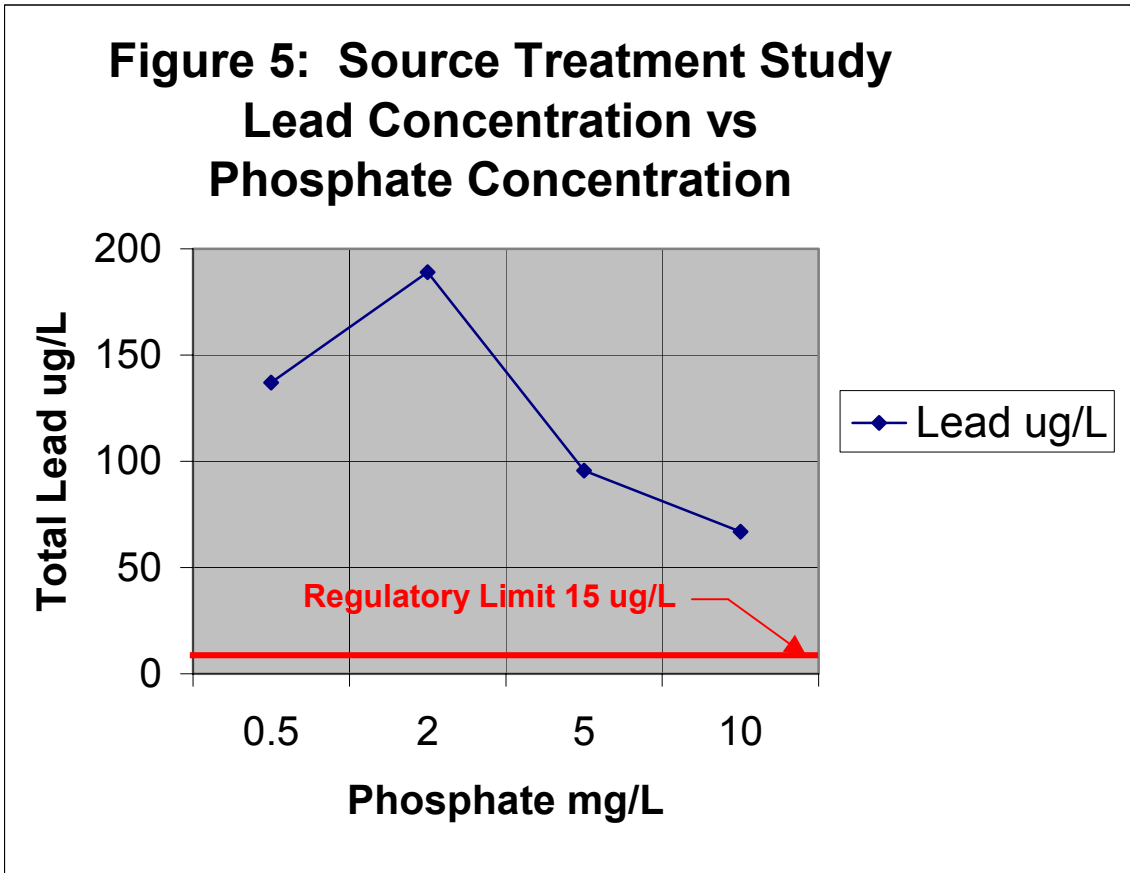
The corrosion control study performed in 2000 showed that installing a source treatment system does not reduce analytical results to compliance levels. That report concluded that the introduction of calcium phosphate was the most effective source treatment option for the site conditions on Adak. In the laboratory test calcium phosphate was found to lower concentrations of lead by 80%, however it was unable to meet the regulatory limit of 15 ug/L. Figure 5 displays the reduction of lead concentration with the introduction of phosphate.

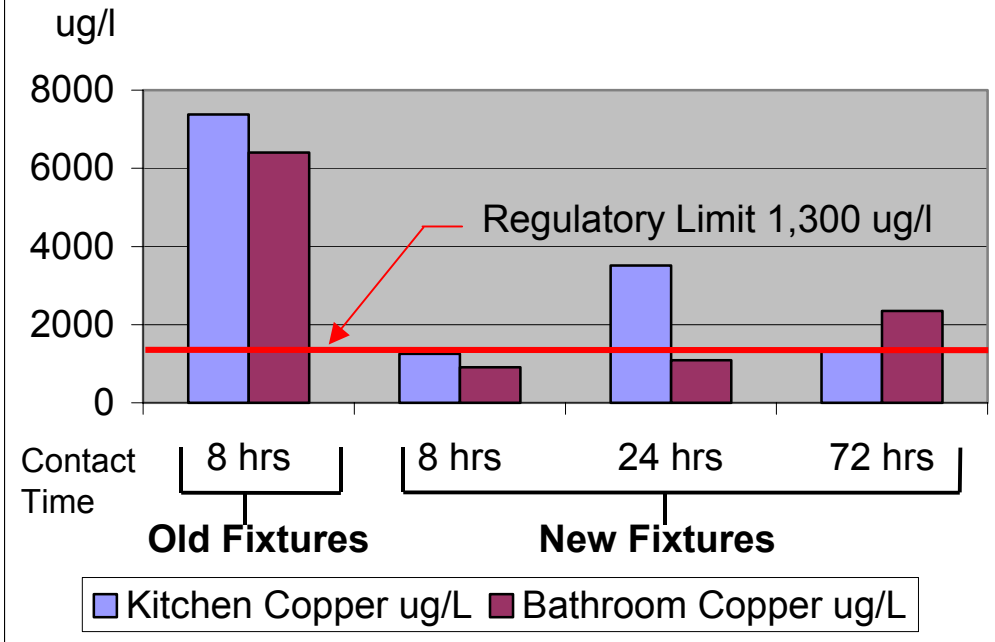
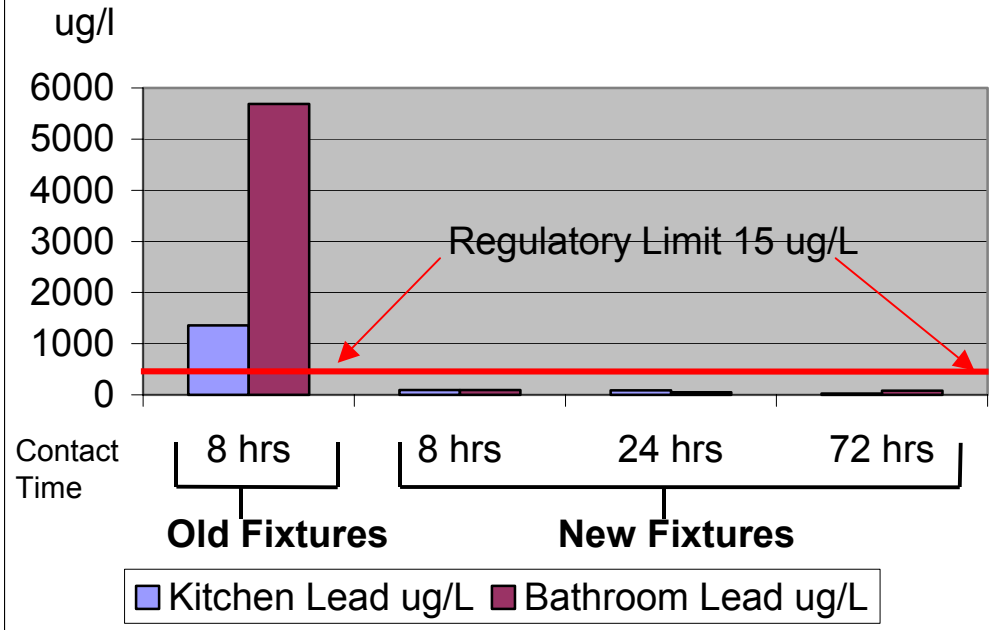
The data was fairly consistent and followed an overall trend, of increasing metal concentration directly proportional to time left undisturbed in the piping. The only anomaly was the data collected from Housing Unit 162D. The measured value for both lead and copper in this unit did not follow the overall trend of the sampling data. Lead concentrations were measured to be 5690 ug/L, which was significantly higher than the other units. Similarly, the result for copper was found to be 7380 ug/L, which was much higher than the other units. It is not known if the cause of the unusually high readings was due to a laboratory or sampling error. The high result may be an artifact of the unit being inactive for a considerable amount of time, thus allowing the water to leach a considerable amount of material from the piping system. The hydraulic action of flushing the system for 15 minutes may have loosened the particulate matter within the piping system. Subsequently, flakes of piping material may have been captured in the sampling containers yielding unusually high readings.

**Figure 21: Copper Sampling Results
Unit 162 D**

**Figure 22: Lead Sampling
Results Unit 162 D**

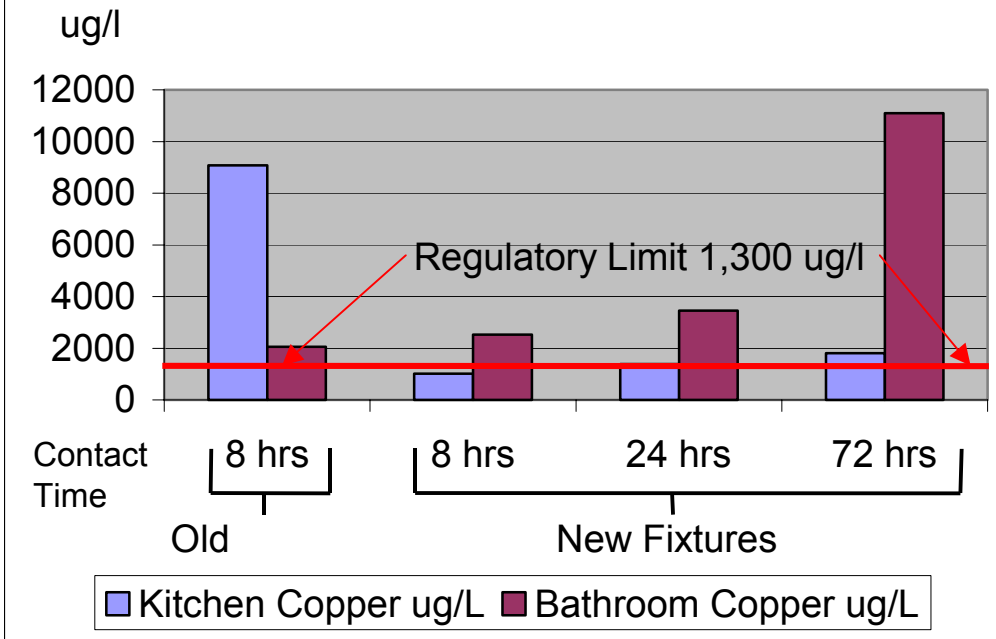
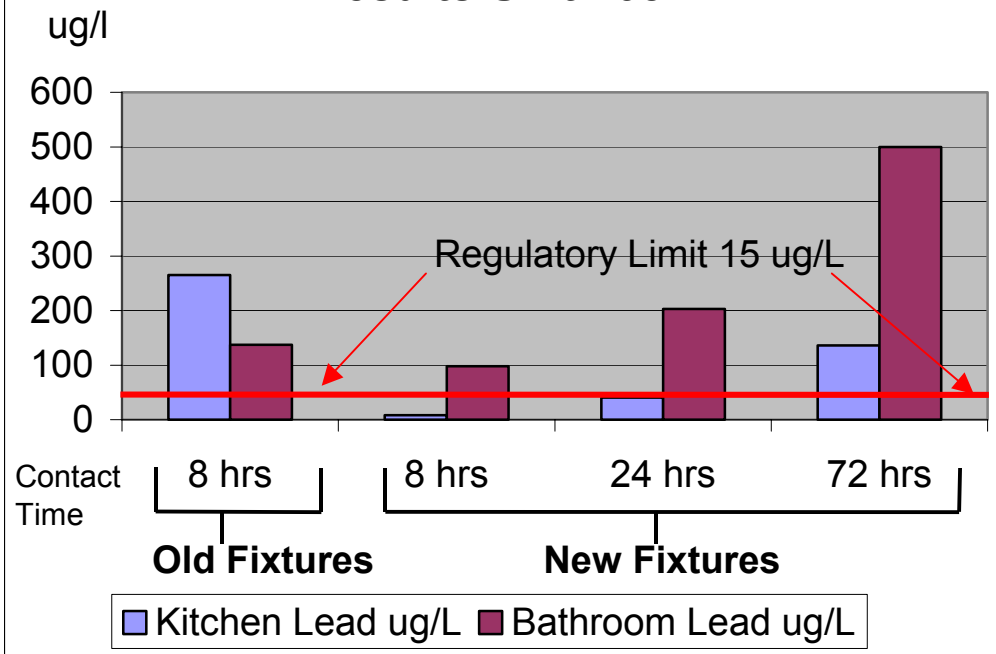
period. The anomaly that was encountered was found from Housing Unit 168A. The measured values for both lead and copper were much higher and did not follow the overall trend of the sampling data. Copper concentrations for the unit were measured to be 11,100, which were orders of magnitude higher than the other units. Similarly, the results for lead in the unit were found to be as high as 500 ug/L, which was much higher than the other units. It is not known if the cause of the high readings was due to laboratory or sampling error. The high result may be an artifact of the unit being inactive for a considerable amount of time thus allowing the water the opportunity to leach a considerable amount of material from the piping system. The hydraulic action of flushing the system for 15 minutes may have loosened the particulate matter within the piping system. Flakes of piping material may have been captured in the sampling containers yielding unusually high readings.

Figure 23: Copper Sampling Results Unit 168 A

Figure 24: Lead Sampling Results Unit 168 A
